# Cold Bay Health Clinic

## Alaska Rural Primary Care Facility

### Assessment and Inventory Report

**May 11, 2004**

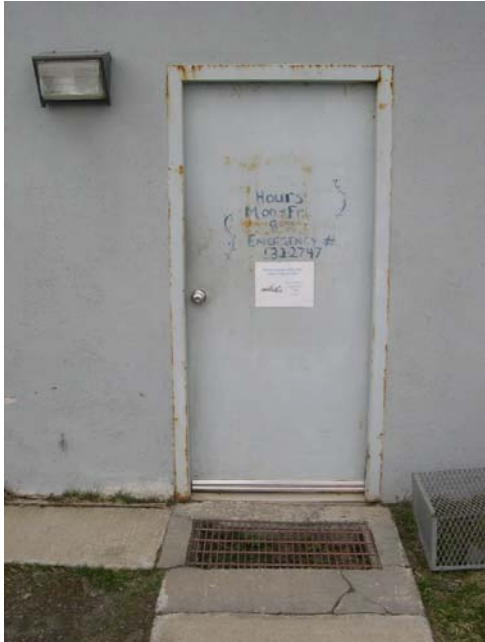
**Aco01**

<b>Architectural Deficiencies</b>			
<b>Item #</b>	<b>Code</b>	<b>Deficiency</b>	<b>Suggested Resolution &amp; Rough Order of Magnitude Cost Estimate</b>
Aco01	01	No canopy over building entrances.	Construct canopies over both exterior door approaches. \$20,000
Aco02	01	Drop off from concrete walk outside of Storage Room [119] door.	Remove concrete stoop, re-grade as required. Provide new concrete stoop \$1,000
Aco03	03	Exterior wall penetrations (used and unused) not properly sealed or patched.	Patch unused wall penetrations and properly seal used wall penetrations. \$100
Aco04	04	Exposed rebar.	Patch and seal. \$200
Aco05	04	Crack/shift in foundation system.	Patch and seal. \$200
Aco06	04	Concrete broken / rebar support exposed on building corner.	Patch and seal. \$200
Aco07	03	Crumbling retaining wall.	Remove existing retaining wall. Re-grade slope to even transition. \$500
Aco08	01	No railing along concrete walk to building entrance at drop off.	Install pipe guardrail and handrail (apprx 10 Ft.). \$500

flow of exit traffic, especially in an emergency, more intuitive; both exit doors have been reconfigured to swing outwards. {Aco38} A new arctic entry [RM#121] has been installed at the street-side exit to provide a weather lock. {Aco01} Also, both exits have canopies installed over them, to provide protection from rain and snow. {Aco13} The two exit doors, as well as the Storage/Generator [RM#119] door, will be replaced with painted insulated hollow-core metal doors and frames with proper seals to prevent wind and water entering the building.

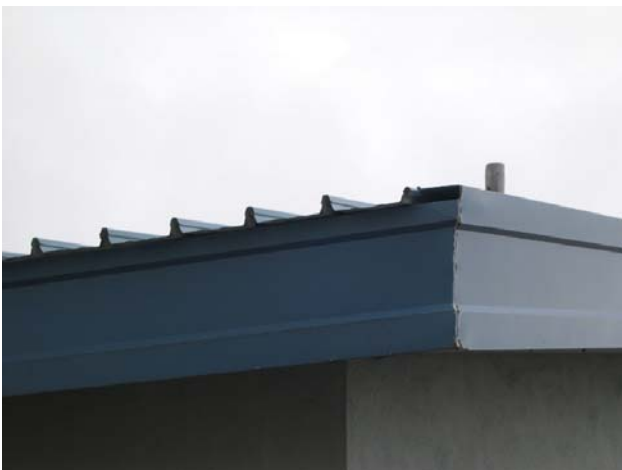
**Aco11**

Aco09	01	No landing at top of ramp.	Reconfigure top of ramp to include a flat landing in front of the door. See Proposed Plans A4 & A4. \$1000
Aco10	10	Rusting metal roof fascia.	Sand, seal and paint. \$150
Aco11	10	No edge flashing on metal roof.	Install edge flashing on metal roof. \$150
Aco12	10	No gutters.	Install gutters and downspouts. \$2000
Aco13	03	All exterior doors (except overhead door) are rusted and lack proper seals. Hardware is not ADA.	Replace exterior doors, frames and hardware with new fiberglass doors and frames. (3) @ \$1,500 ea. = \$4,500
Aco14	02	All interior doors lack ADA compliant hardware.	Install ADA compliant hardware on all doors. (13) @ \$300 ea. = \$3,900
Aco15	01	Exterior doors lack panic hardware and have improper swing direction. Rooms [100] and [107].	Reconfigure doors to swing out and install panic hardware. See Proposed Renovations A6 & A7. Costs for this deficiency are included in Aco13.

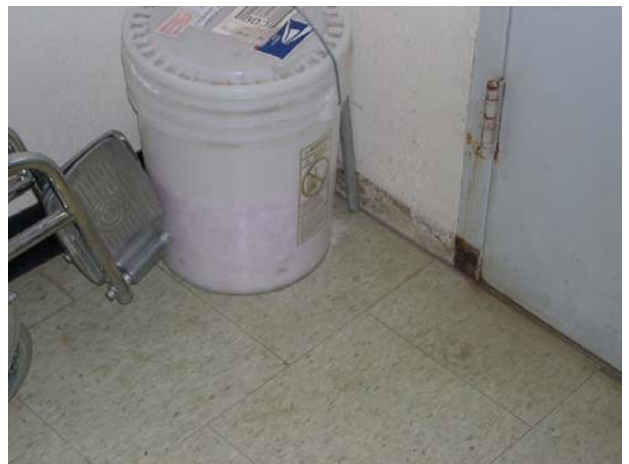
**Aco16**

Aco16	03	Missing wall base in Corridor [100].	Replace missing rubber wall base. Costs

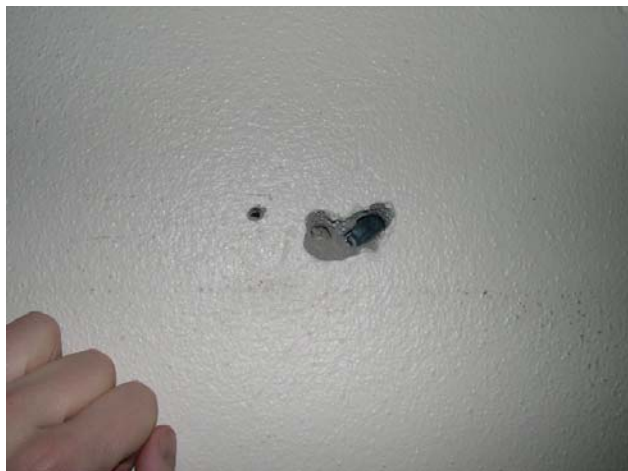
**Aco17**

for this deficiency are included in Aco25.
Aco17	03	Unused interior wall penetrations not patched. Room [101].	Patch unused wall penetration. \$100
Aco18	01	Rug prevents proper door operation. Room [101].	Remove rug to allow proper door operation. \$0
Aco19	02	Objects/casework preventing proper door clearance for ADA compliance. Rooms [101] [102] [103] [104] and [114].	Move obstructing objects or partially remove casework to provide ADA compliant door approach clearances. \$0
Aco20	01	Same room being used for Ward and Break room. Room [102].	Redefine spaces to provide a separate Ward room. See Proposed Plans A4 & A5.
Aco21	01	Door swing of Exam [104] obstructs access to Office [105].	Reconfigure door to swing inwards. See Proposed Plans A4 & A5. \$150
Aco22	01	Seating in Waiting Room [106] obstructs opening to X-ray [109].	Install solid partition behind seating and decrease opening width. See Proposed Plans A4 & A5. \$2,500

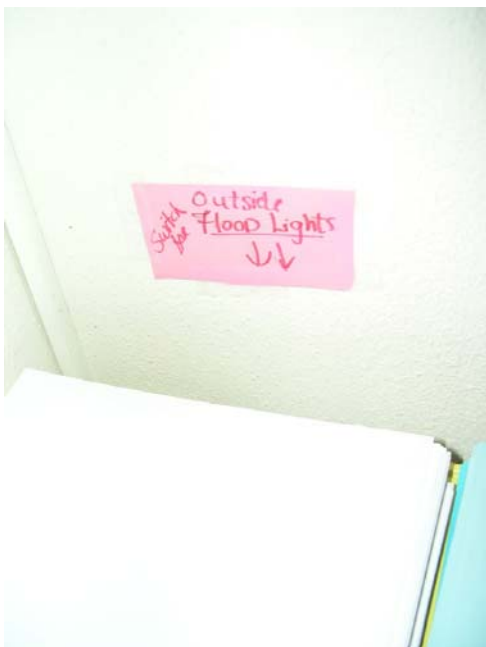
Aco23	01	Switch in Exit [107] for exterior lights hidden by shelving.	Remove shelving. \$100
Aco24	03	No privacy for patients going to, or in X-ray [109].	Enclose X-ray [109] with controls in a room with a normal door. \$4,000
Aco25	03	Damaged vinyl tile flooring.	Remove tile vinyl tile flooring throughout and replace with welded seam vinyl flooring with integral cove base. \$15,000
Aco26	01	Pharmacy [111] door and cabinets unlocked.	Provide proper security for pharmacy. Costs for this deficiency are included in Aco14.
Aco27	02	Insufficient room for ADA compliant turn radius in HC RR [112].	Reconfigure rest room layouts [112] and [113]. See Proposed Plans A4 & A5. \$5000
Aco28	03	Washing machine in Laund. [115] obstructing door from proper operation.	Relocate washing machine. See Proposed Plans A4 & A5. \$0
Aco29	01	Linens on floor in Laund. [115] between washing machine and dryer.	Provide storage location for laundered and unlaundered linens. \$0

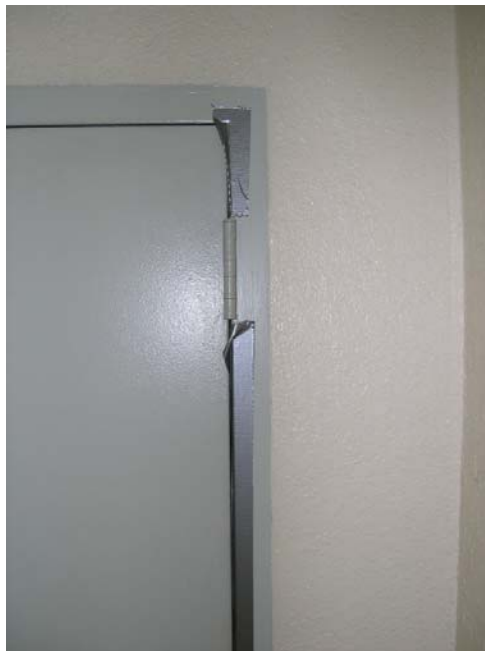
**Aco32**

Aco32	03	Non-working seals on door between Corridor [100] and Ambulance Bay [118].	Replace door seals. \$100
Aco33	01	Door threshold between Corridor [100] and Ambulance Bay [118] exceeds ½".	Install new threshold. \$150
Aco34	01	No guardrails on ramps or platform in Ambulance Bay [118].	Install guardrails and handrails where required. Install removable guardrail for ambulance unloading. \$1000
Aco35	01	Objects preventing proper operation of exterior door in Storage/Generator [119].	Provide proper storage. \$0
Aco36	01	Only light switch in Storage/Generator [119] by exterior door.	Install new light switch inside of the door between Storage/Generator [119] and Ambulance Bay [118]. \$200
Aco37	01	Clutter and improper storage in several rooms and Corridor [100].	Relocate unnecessarily stored objects from the corridor and use more organized storage. \$0
Aco38	03	No Arctic Entry at street entrance.	Install Arctic Entry. See Proposed Plans A4 & A5. \$4,000

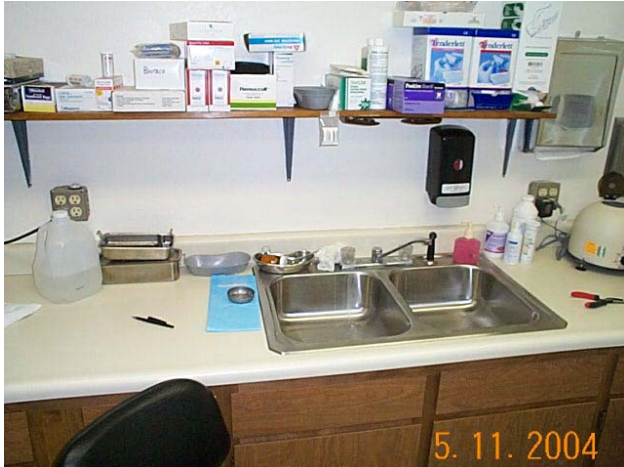
**Eco05**

supported below the transfer switch. NEC 350.30.	\$50
Eco04	13	Provide cover plates for existing junction boxes around the facility with no cover allowing energized conductors to be out of the enclosure. NEC 110.12.	Provide blank covers for all open junction boxes. Assume 5 are required. \$50
Eco05	13	GFCI protection for receptacles located adjacent to sinks are not provided.	Provide GCFI protection for each receptacle located near sinks. This is not a code requirement but considered good design practice. Assume 8 are required. \$800
Eco06	2	One single station smoke detector is installed. No fire alarm system is installed.	The inspection criteria requires a fire alarm system however for this facility it appears a fire alarm system is not required by code provided no one sleeps at the clinic. \$0
Eco07	2	No illuminated exit signs are installed.	Provide illuminated exit signs per IBC requirements. Assume 14 units are required. \$2,800

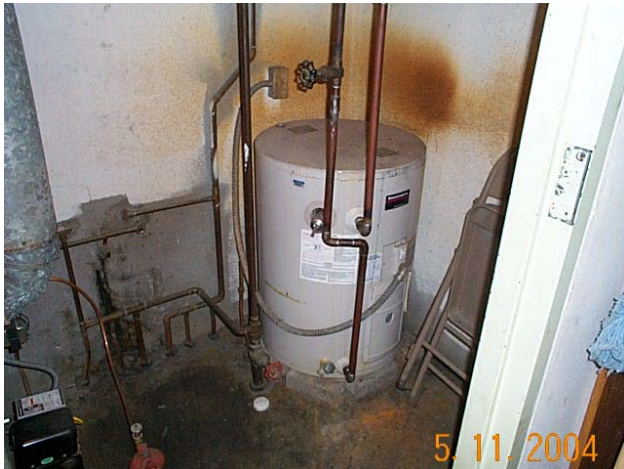
The electric water heater is installed in the furnace room. Access to the water heater is limited. The water heater is not operating correctly and will need to be replaced.

**MGE05  
Electric Water Heater**
